Manhole Inspection Summary

Manhole # S47EE_031MH

Insp Date: **7/17/08 8:40 AM**

Location Address: **Montford**

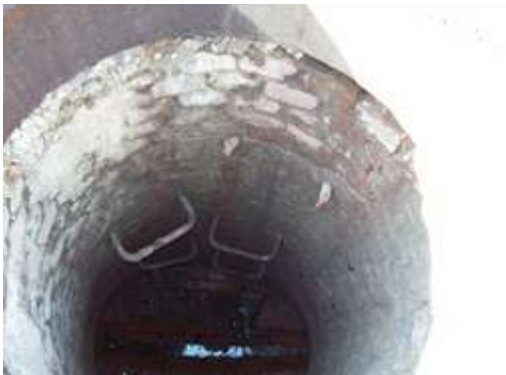
Defect 1

Condition: ☐ Sound ☐ Cracked ☐ Root Intrusion ☒ **Loose Brick** ☐ Deteriorated

Infiltration: ☐ None ☐ Joint ☐ Cracks ☒ **Mortar** ☐ Roots ☐ Wall

Loose bricks

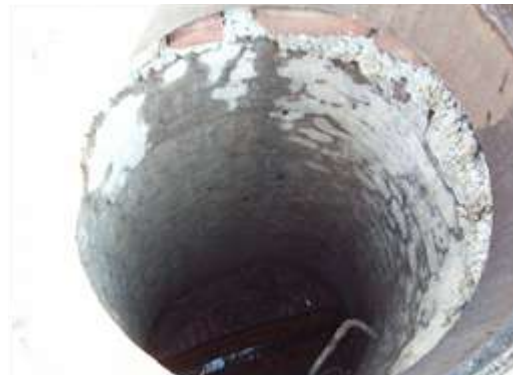
Defect 2

Frame Offset: **0** (in.) Condition: ☐ Sound ☐ Cracked ☒ **Leaks**

Frame leaks

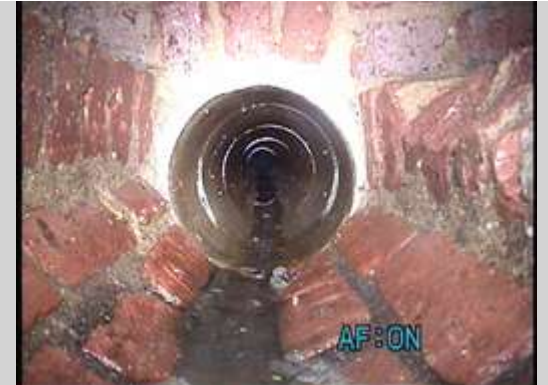
12 O'Clock Outflow

8 in. Circular Gravity Sewer
Pipe Out @ 12 O'Clock

Pipe Height: **8.4** (in.) Rod and Bar (Angled)
Pipe Material: **Clay** ☐ Pipe Lined
Invert Depth: **10.60** (ft.) Flow Characteristics: **Slow**
Deposits: ☒ None ☐ Mud ☐ Sludge ☐ Debris ☐ Grease
Silt Depth: (in.) Deposits Extent:
Infiltration: **None** Pipe Seal Cond: **Sound**

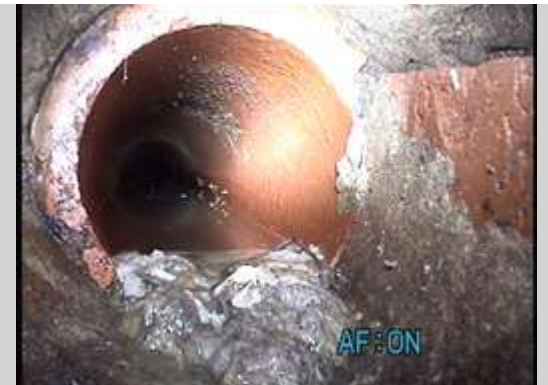
3 O'Clock Inflow

6 in. Circular Gravity Sewer
Pipe In @ 3 O'Clock

Pipe Height: **6** (in.) Rod and Bar (Angled)
Pipe Material: **Clay** ☐ Pipe Lined
Invert Depth: **10.20** (ft.) Flow Characteristics: **Slow**
Deposits: ☒ None ☐ Mud ☐ Sludge ☐ Debris ☐ Grease
Silt Depth: (in.) Deposits Extent:
Infiltration: **None** Pipe Seal Cond: **Sound**

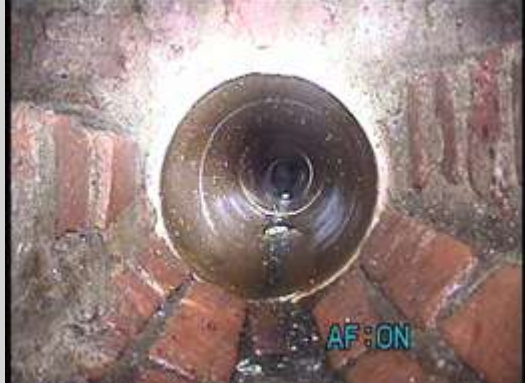
6 O'Clock Inflow

8 in. Circular Gravity Sewer
Pipe In @ 6 O'Clock

Pipe Height: **8.4** (in.) Rod and Bar (Angled)

Infiltration: **None** Pipe Seal Cond: **Sound**
